REPORT OF APOLLO 13 REVIEW BOARD

NATIONAL AERONAUTICS AND SPACE ADMINISTRATION

June 15, 1970

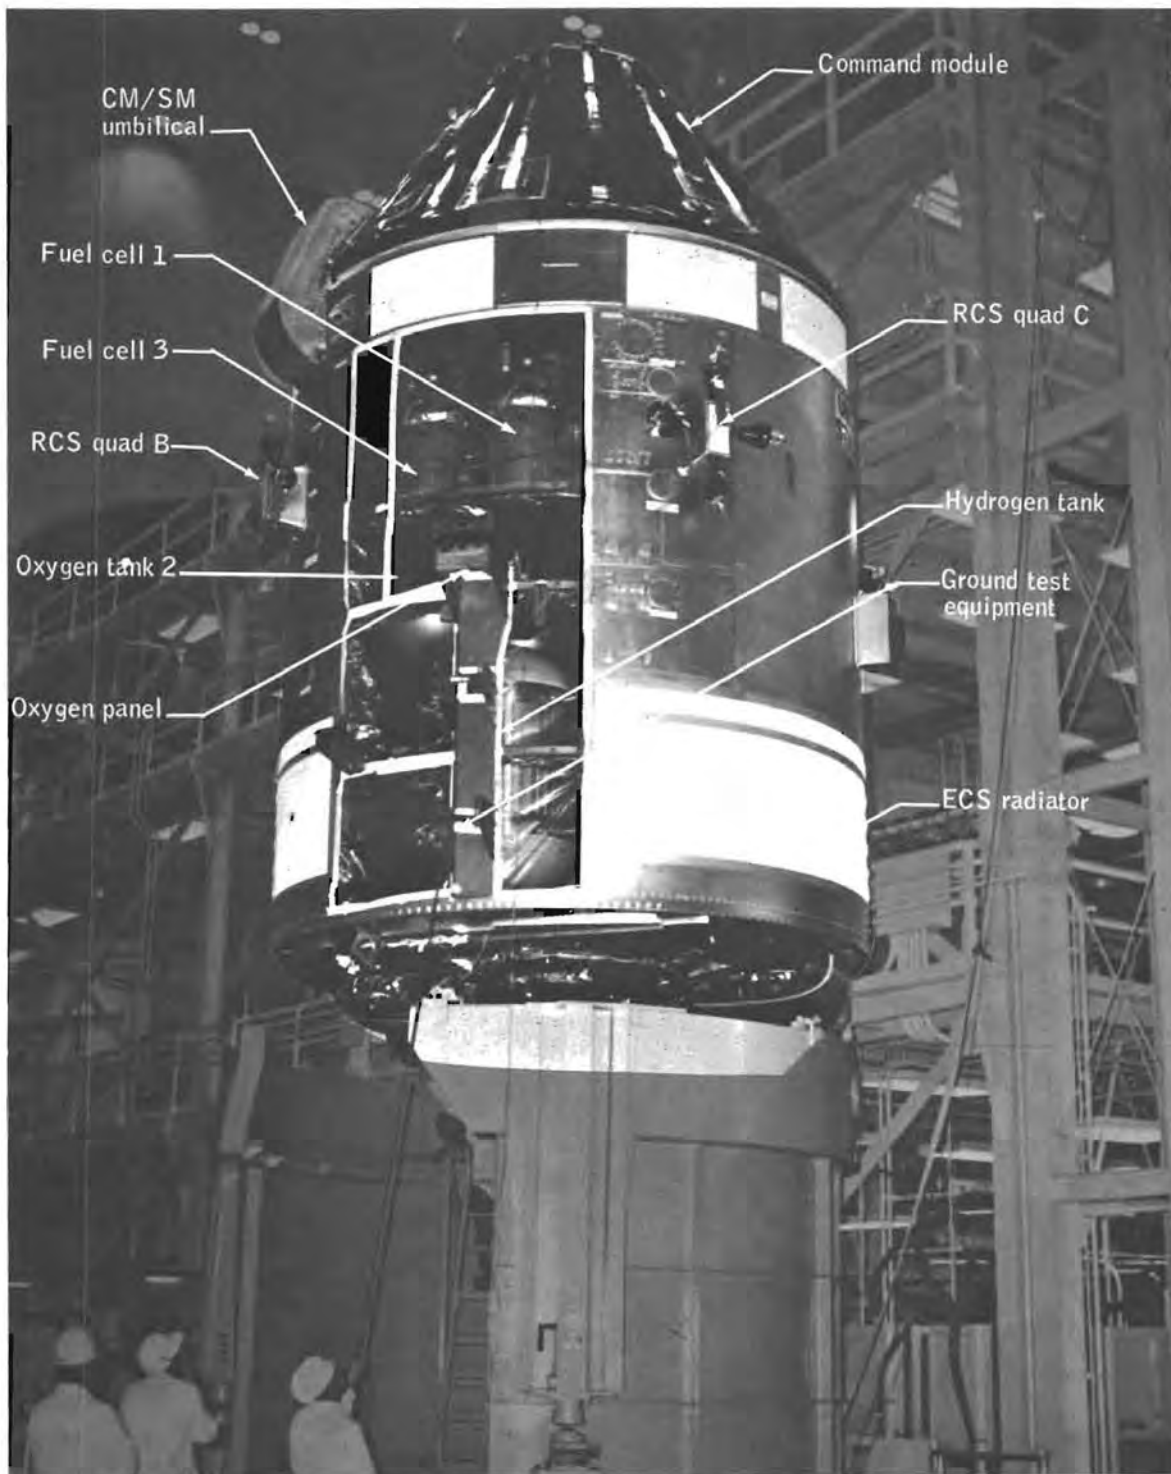
CSM in ground test with bay 4 panel removed.

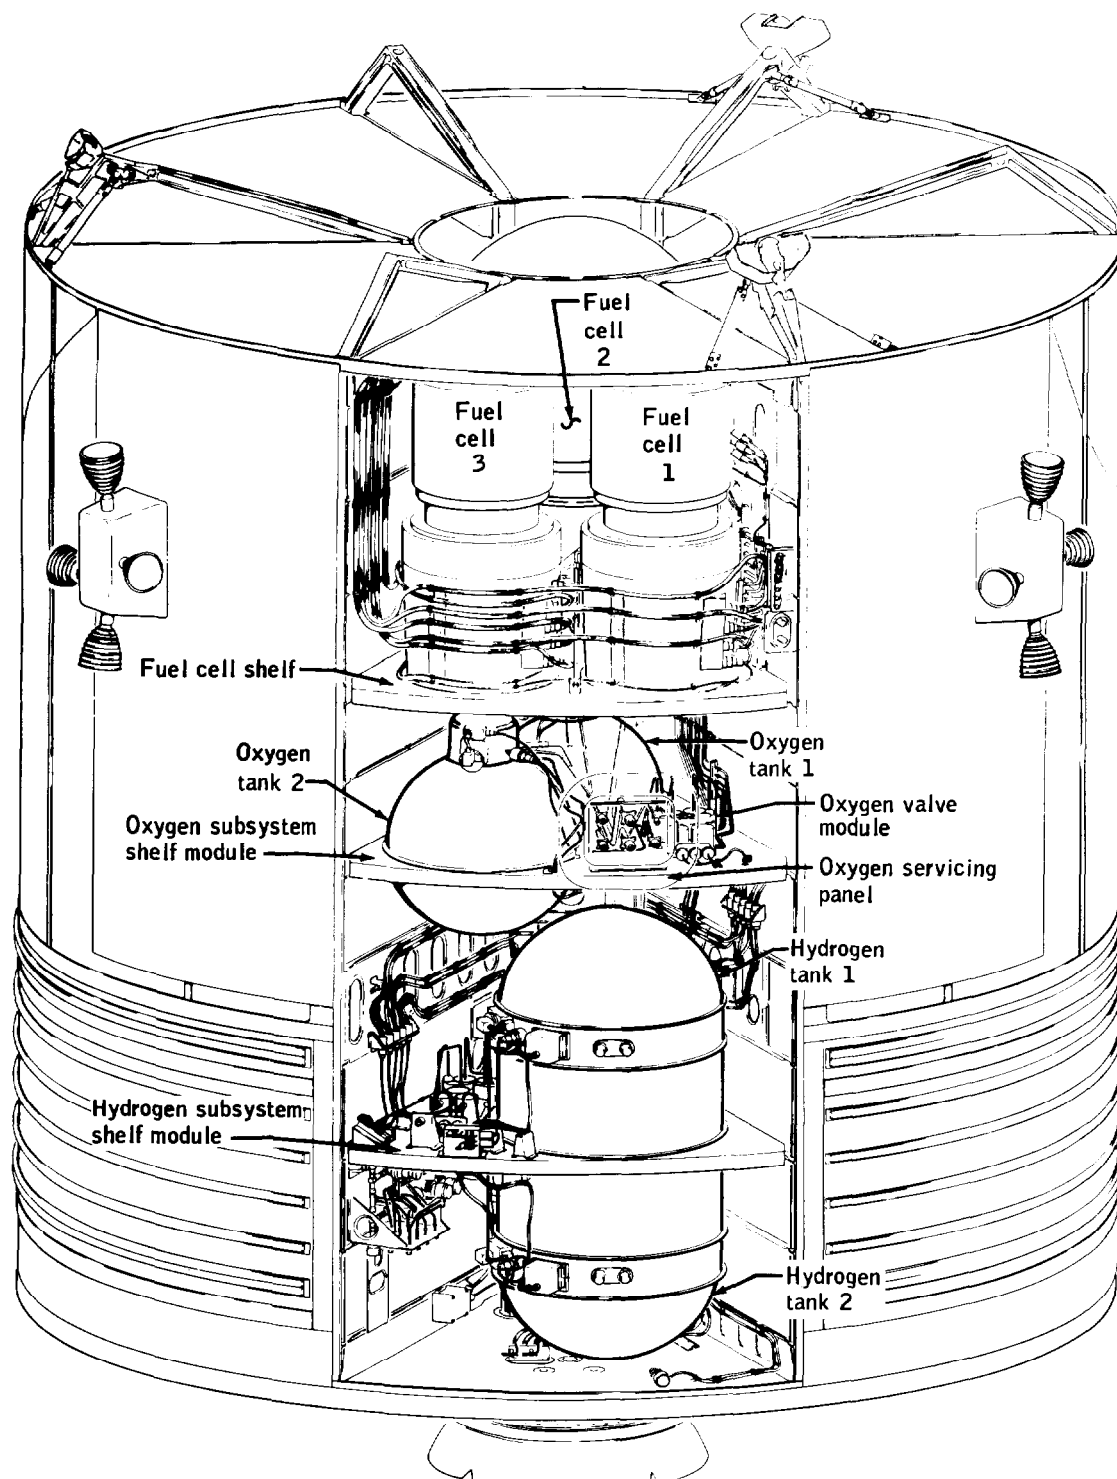
Figure 4-4.- Arrangement of fuel cells and cryogenic systems in bay 4.

Two oxygen tanks are mounted on a shelf in bay 4 of the SM, as shown in figure 4-4. Figures 4-5 through 4-8 are photographs of portions

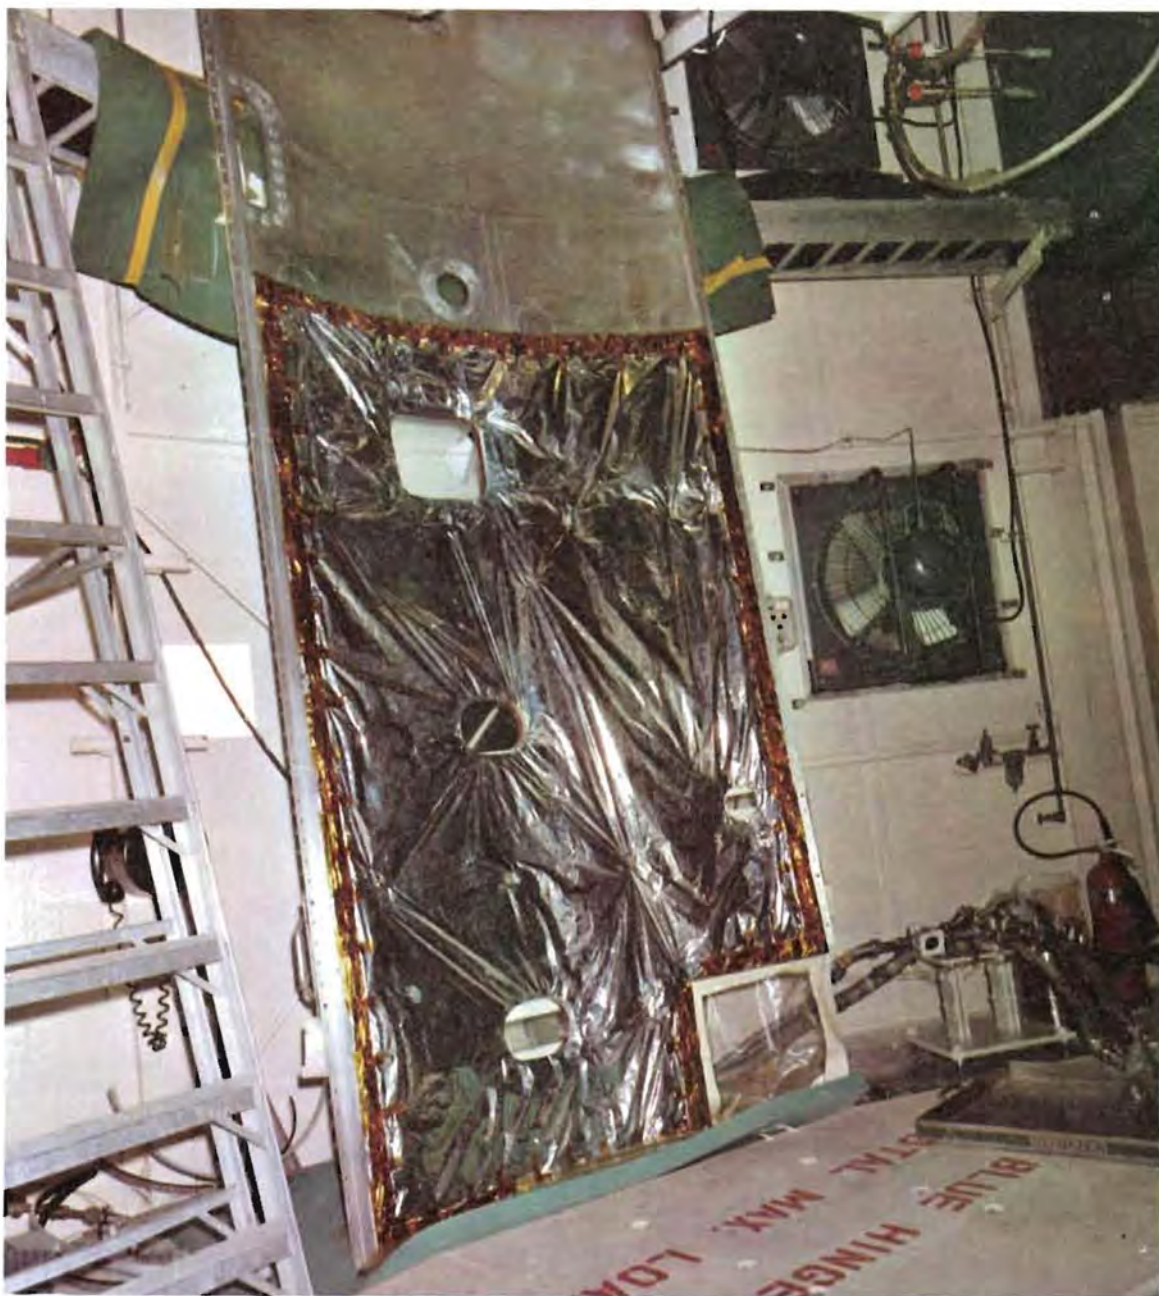
4-8.-
Figure ~~XXX~~ Inside view of panel covering bay 4.

of the Apollo 13 service module (SM 109) at the North American Rockwell plant prior to shipment to KSC. Figure 4-5 shows the fuel cell shelf, with fuel cell 1 on the right, fuel cell 3 on the left, and fuel cell 2 behind cells 1 and 3. The top of oxygen tank no. 2 can be seen at the lower left. Figure 4-6 shows the oxygen tank shelf, with oxygen tank no. 2 at left center. Figure 4-7 shows the hydrogen tank shelf with hydrogen tank no. 1 on top and hydrogen tank no. 2 below. The bottom of the oxygen shelf shows some of the oxygen system instrumentation and wiring, largely covered by insulation. Figure 4-8 is a photograph of the bay 4 panel, which was missing from the service module after the accident.
